FLOORING

ALOCIT 28.95, 28.96 & 28.15

CASE STUDY

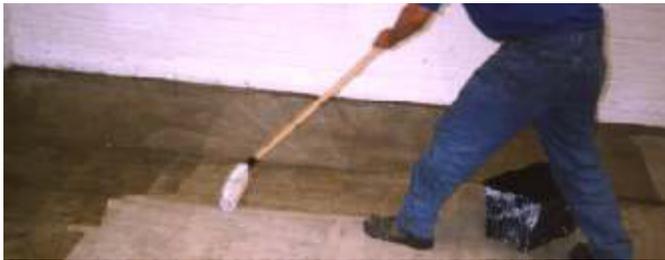
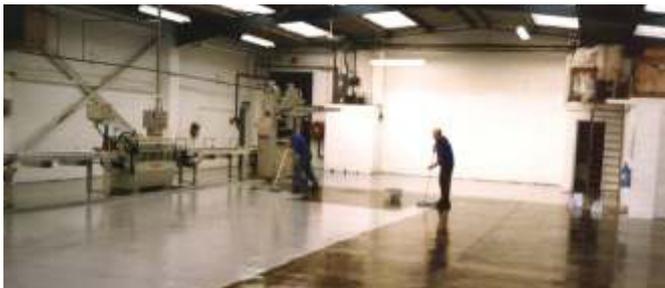
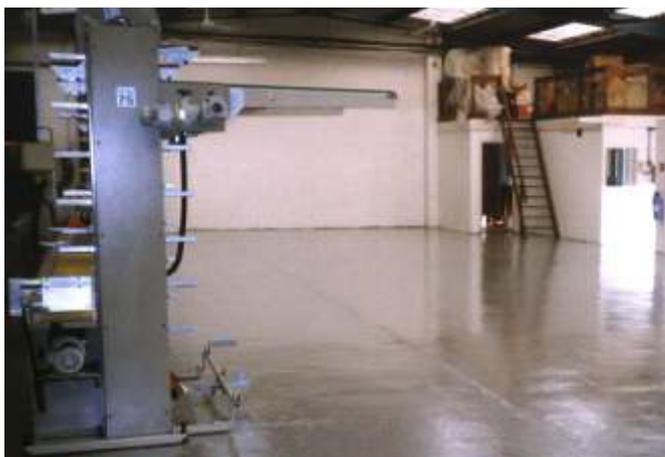
Although of fairly recent construction, the concrete flooring in this factory unit had become unsightly, with patches of ingrained dirt and oil as well as cracking and pitting. The degree of contamination meant that the new coating would have to adhere to a surface with areas that retained considerable quantities of oil despite thorough cleaning .

The pictures show, from the top, water jetting the contaminated surfaces, stripe coating the edges, application of 28.95 then 28.15 by roller and, finally, the finished floor.

The floor was cleaned using a high-pressure water jet with surface water removed by vacuum machines. This was followed by crack filling with 28.96 and a stripe coat of 28.95 around all the edges. The entire floor was then primed, producing a perfect surface for the application of the finishing coat.

The materials were applied using a roller, with wet film thickness testing at all stages to ensure an even coating. The primer coat was 150 microns and the top coat 300 microns, giving a hard wearing and attractive finish to the factory floor.
