WASTE WATER PLANT

ALOCIT 28.95 & 28.15

CASE STUDY

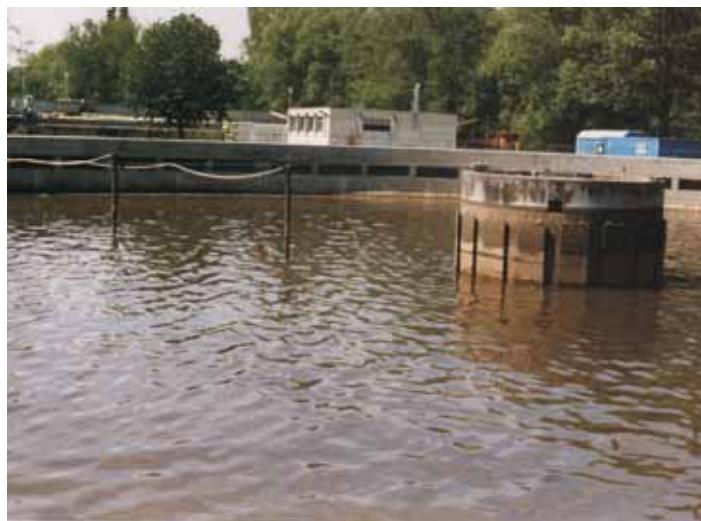
Diagram on left shows areas referred to in the chart above.

LOCATION OF SAMPLE	SAMPLE NO	FAILURE @	FAILURE LOCATION	
TOP SECTION	BK 6	1.7%/ m^2	Failure Between Mortar And Concrete	
	BK 8	2.2%/ m^2		
MIDDLE SECTION	BK 10	1.4%/ m^2		
	BK 14	2.9%/ m^2		
	BK 16	2.3%/ m^2		
BOTTOM SECTION	BK 18	2.2%/ m^2	Concrete broke away at 20-30mm Depth	
	BK 24	3.2%/ m^2		
	BK 26	3.9%/ m^2		
	BK 28	3.5%/ m^2

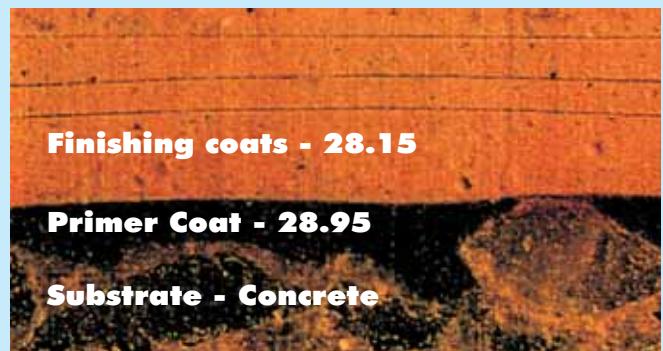
Shown right: A magnified section of a core sample with the four coats clearly showing. Note how the primer coat penetrates and smooths the substrate.

Throughout the project coatings were regularly tested for quality. Drill cores were taken during the repair process and verified by laboratory testing. During the individual operating stages tests were carried out on site, including adhesion tensile tests and dry film thickness tests, all of which provided excellent results. The chart on the left shows that, during adhesion tests, there was only failure in the substrate - the Alocit coating remained secure. The second chart shows a sample of the DFT tests which showed excellent coverage throughout the project.
