US COASTGUARD

ENVIROPEEL 170 IN USCG BUFF & WHITE

CASE STUDY

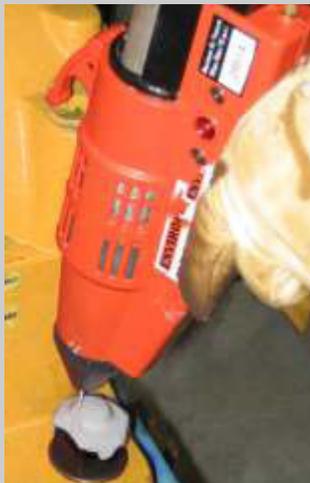
The first applications were at the California USCG HQ on Alameda Island, using the Slugger 170 hand-held unit.

successful technical review of these issues by USCG, an initial demonstration was arranged at the USCG's Alameda HQ in California, using the Slugger 170 hand-held unit as the most cost-effective introduction to the function of the system. The trials also attracted the

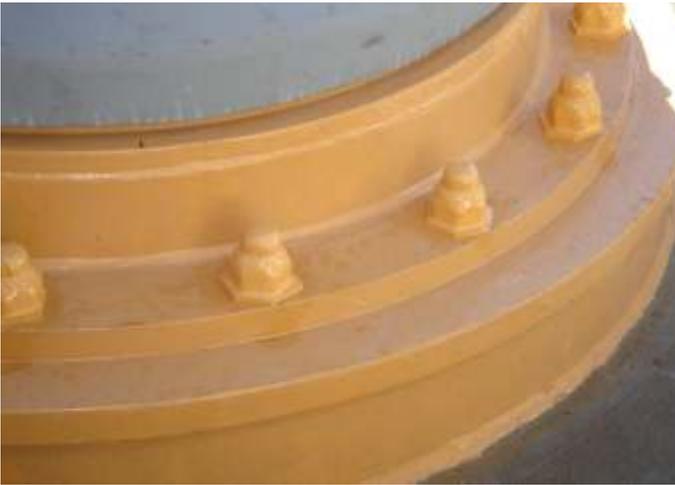
Top left: Tailor-made bolt caps from the Slugger 170.

The first tests were to cap a series of bolt heads on various flanges to demonstrate the simplicity and effectiveness of using Enviropeel. These were so successful that a larger demonstration was arranged on the USCGC Healey in Puget Sound. As the Healey's mission would take it to arctic waters, a full-scale application on the

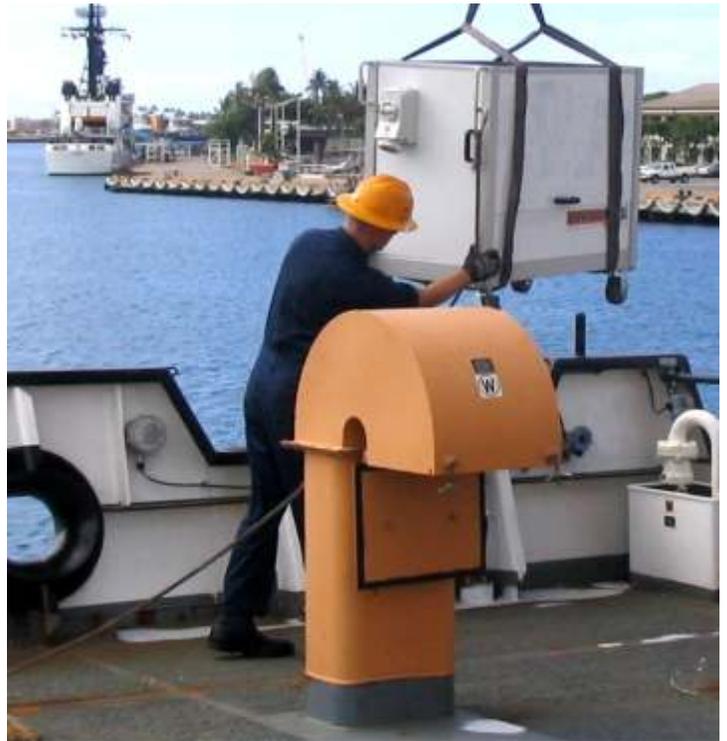
Top right: The standard Enviropeel C12 unit is loaded aboard the Kukui in Hawaii. The unit weighs 220 kgs (484 lbs) and is equipped with a 10 metre (33 ft) application hose and spray gun.

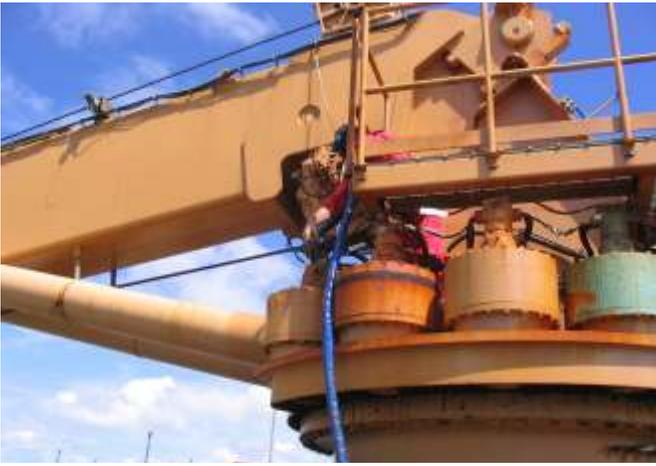
Above: Rusty bolts like these are everywhere, but Enviropeel was specially developed to deal with this problem!

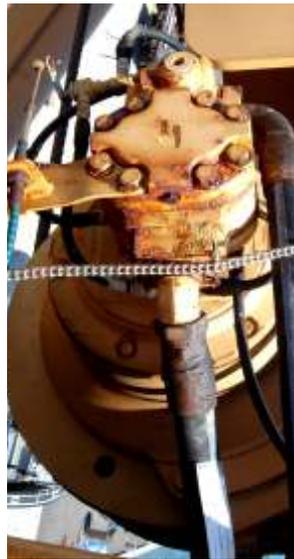
Right: Rusting pipe clamps are sealed and protected using the spray gun on the main unit.

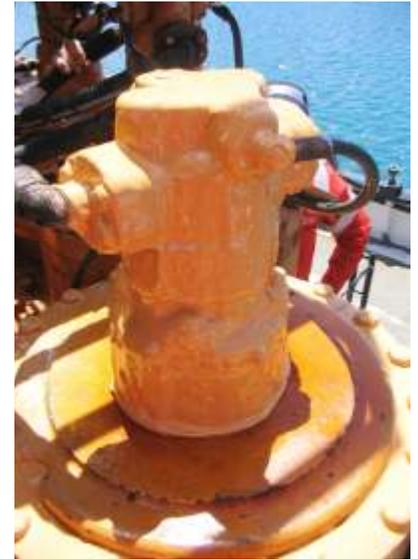
Above: Severe rust is visible on the crane and several motors. Complex assemblies like these motor units on the crane just need to be encapsulated to provide complete protection and prevent any further deterioration occurring.

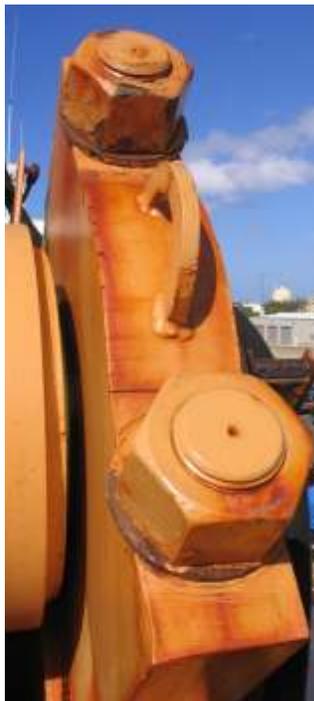
Below: These enormous bolts have exactly the same problems as their smaller counterparts - so the solution is the same - coat them with Enviropeel!
